Manhole Inspection Summary

Manhole # S19C__014MH

Insp Date: **10/15/07 10:29 AM**

Location Address: **513 PULASKI-BRICE**

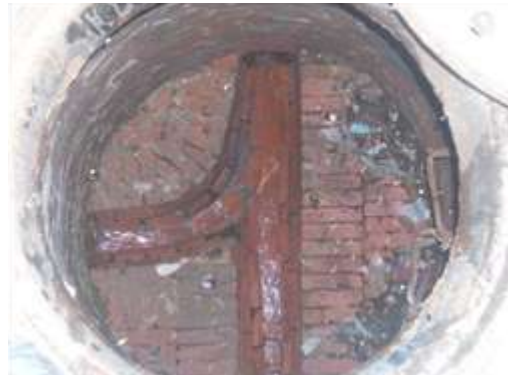
Top View

DEBRIS ON BENCH

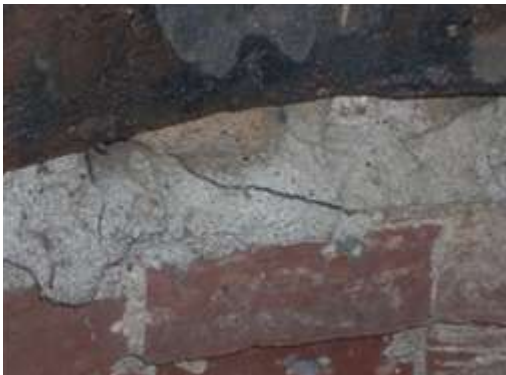
Defect 2

Condition: ☐ Sound ☒ **Cracked** ☐ Root Intrusion ☐ Loose Brick ☒ **Deteriorated**

CRACKS DETERIORATION CHIMNEY

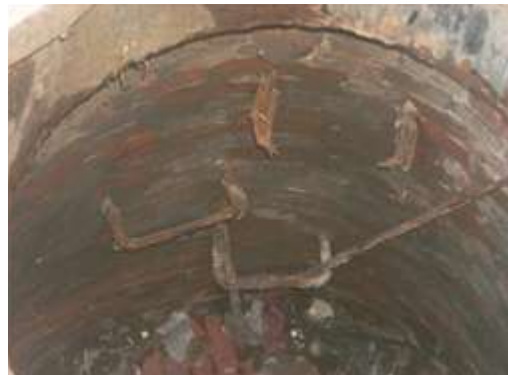
Defect 1

Count: **3** Missing: **1** ☒ **Corroded**

MISSING AND CORRODED STEPS

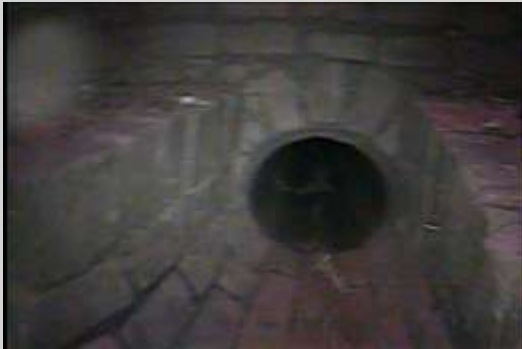
12 O'Clock Outflow

Pipe Height: **8.4** (in.) Rod and Bar (Angled)
Pipe Material: **Clay** ☐ Pipe Lined
Invert Depth: **7.50** (ft.) Flow Characteristics: **Slow**
Deposits: ☒ None ☐ Mud ☐ Sludge ☐ Debris ☐ Grease
Silt Depth: (in.) Deposits Extent:
Infiltration: **None** Pipe Seal Cond: **Sound**

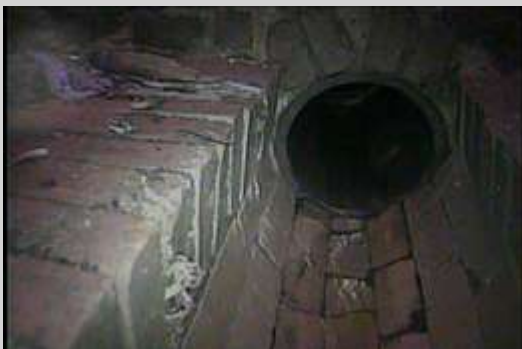
6 O'Clock Inflow

Pipe Height: **8.4** (in.) Rod and Bar (Angled)
Pipe Material: **Clay** ☐ Pipe Lined
Invert Depth: **7.14** (ft.) Flow Characteristics: **Slow**
Deposits: ☒ None ☐ Mud ☐ Sludge ☐ Debris ☐ Grease
Silt Depth: (in.) Deposits Extent:
Infiltration: **None** Pipe Seal Cond: **Sound**

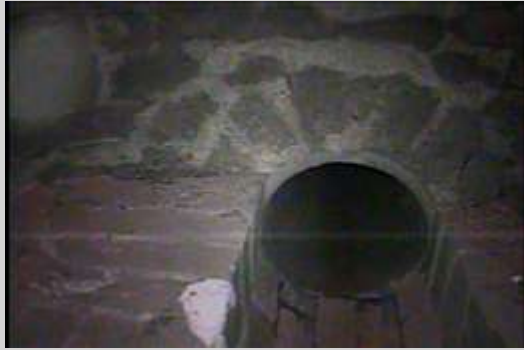
9 O'Clock Inflow

Infiltration: **None** Pipe Seal Cond: **Sound**
